Report on the Investigation of the
Failure of the hatch cover gantry crane on board

CIMBRIS

alongside in the port of Tekirdag, Turkey

4th April 2008

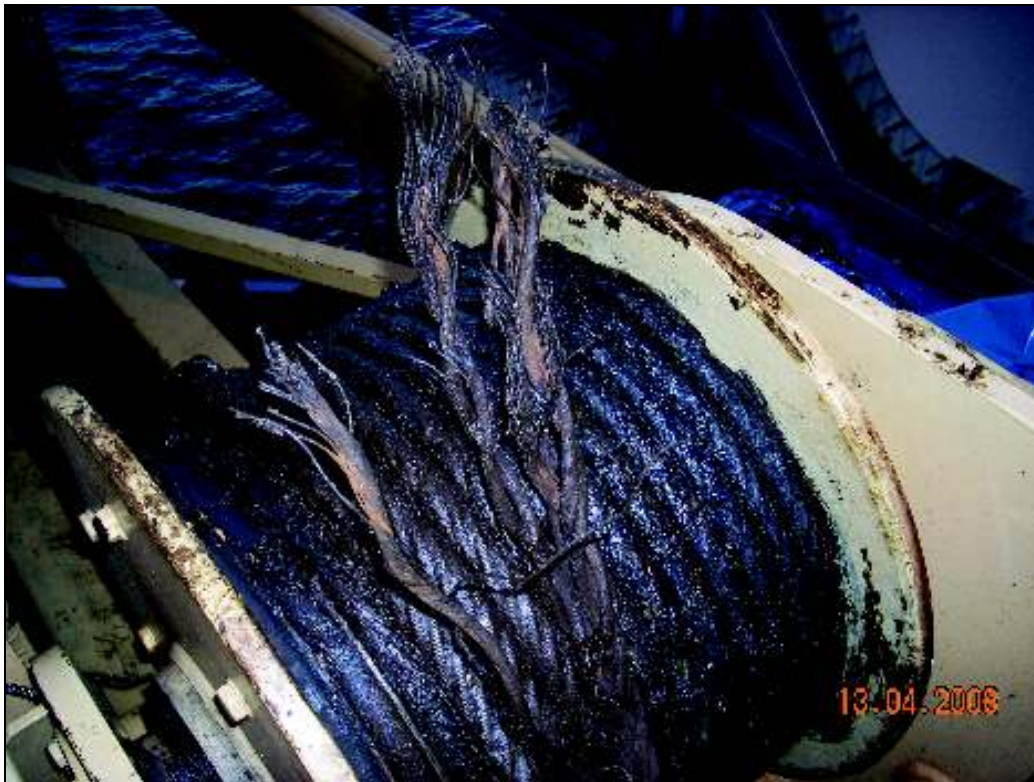
Figure 5. View of failed hoist wire at winch drum showing level of greasing present on wire during normal operation. Corrosion product is also visible on the de-stranded wires at the point of break.

.3 From examination (**Figure 5**) it was apparent that the hoist wires were not subject to cleaning to permit visual inspection as part of the maintenance procedures, with greasing likely to have been applied weekly onto existing grease. Insufficient attention with regard to lubrication would also have been paid to the less accessible locations such as in way of the sheaves.

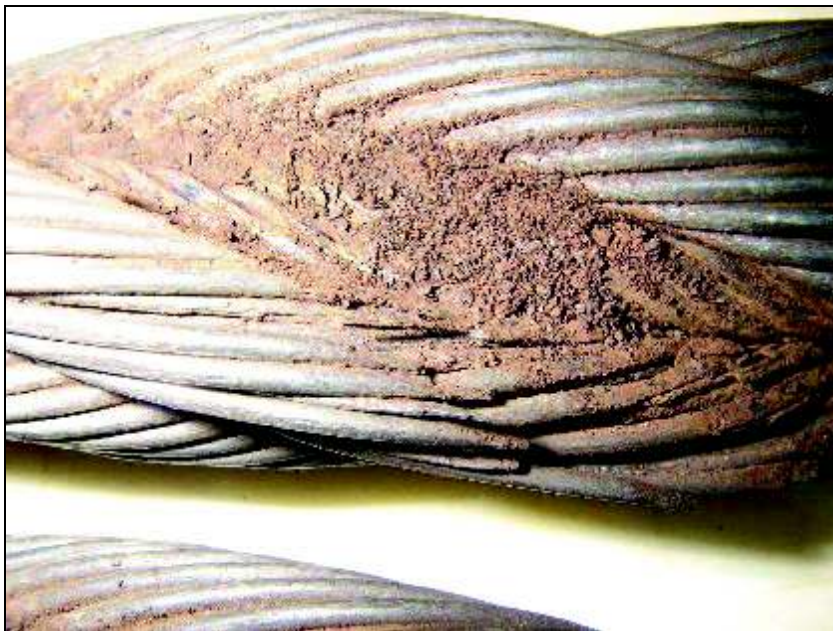
- A number of wire breaks were found in the outer wires of the outer strands, with the wire break ends displaying acute corrosion and the presence of corrosion remaining within the strand space of the wire. Corrosion was found to extend into the core wires of the outer strands, no internal lubrication was found, **(Figure 8)**.
- The outer strands in which outer wire breaks were found were de-stranded, following which wire breaks were also found in the thin and thick Warrington wires, **(Figure 9)**.

Figure 8. Wire breaks located next to each other in the outer strand of the wire adjacent to the points of failure with evidence of acute corrosion.

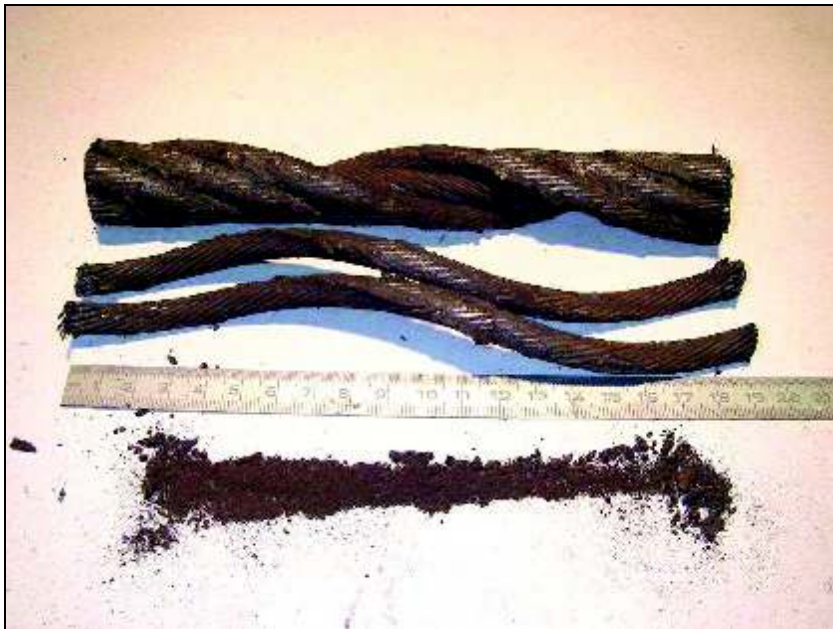
Figure 10. Wire Rope specimen with two separated strands showing the level of corrosion product found within the rope during de-stranding.

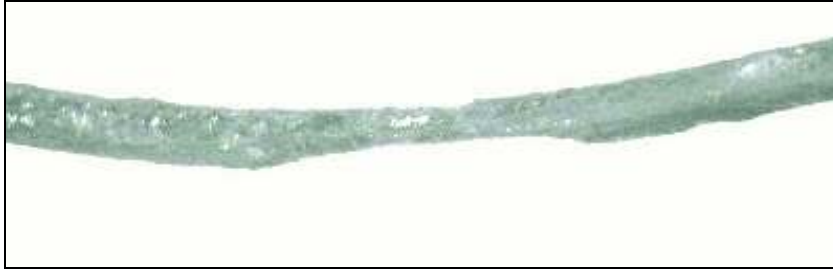
- Upon opening the steel core, wire breaks were found to the outer strands of the steel core and the outer wire of the core strand, (**Figure 11**). Corrosion was also found to have extended to the steel core with the wires of the steel core showing abrasion and dents (**Figure 12**). Only very sporadic galvanizing residues were found on the steel core wires.

Figure 11. Outer wire of outer strand showing abrasion at the contact points as well as corrosion.

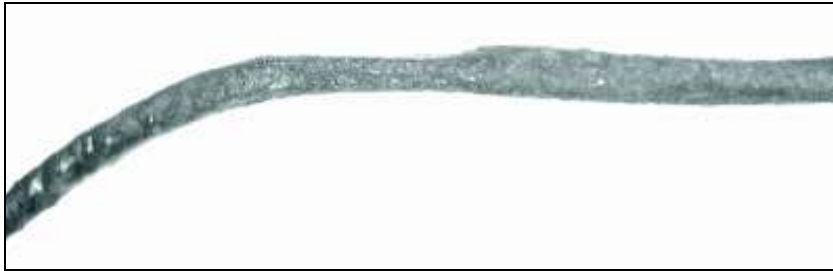
Figure 12. Abrasion on a contact point on an outer wire of the core strand of the steel core.
