# ACCIDENT REPORT

REPORT NO 12/2021

## Fatal crush accident while a gantry crane was moving a hatch cover on board the general cargo vessel *Cimbris*, at Antwerp, Belgium, on 14 July 2020

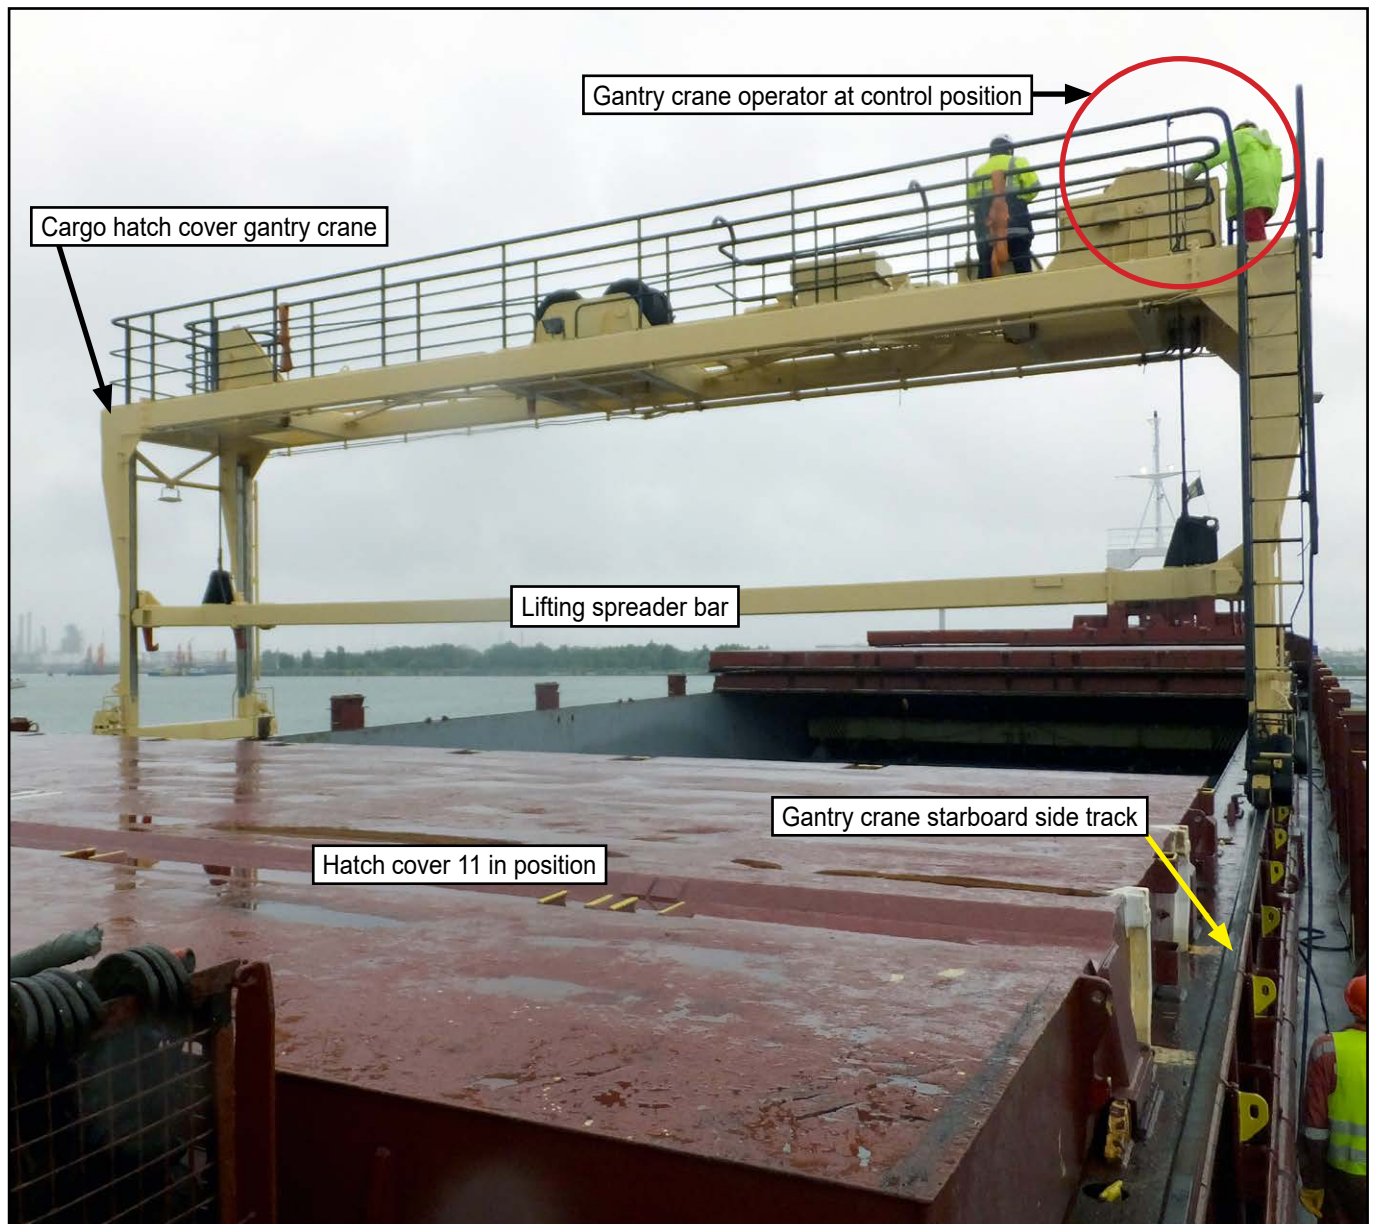
**Figure 1:** *Cimbris*' hatch cover gantry crane (photograph taken from the vessel's starboard side, looking forward)

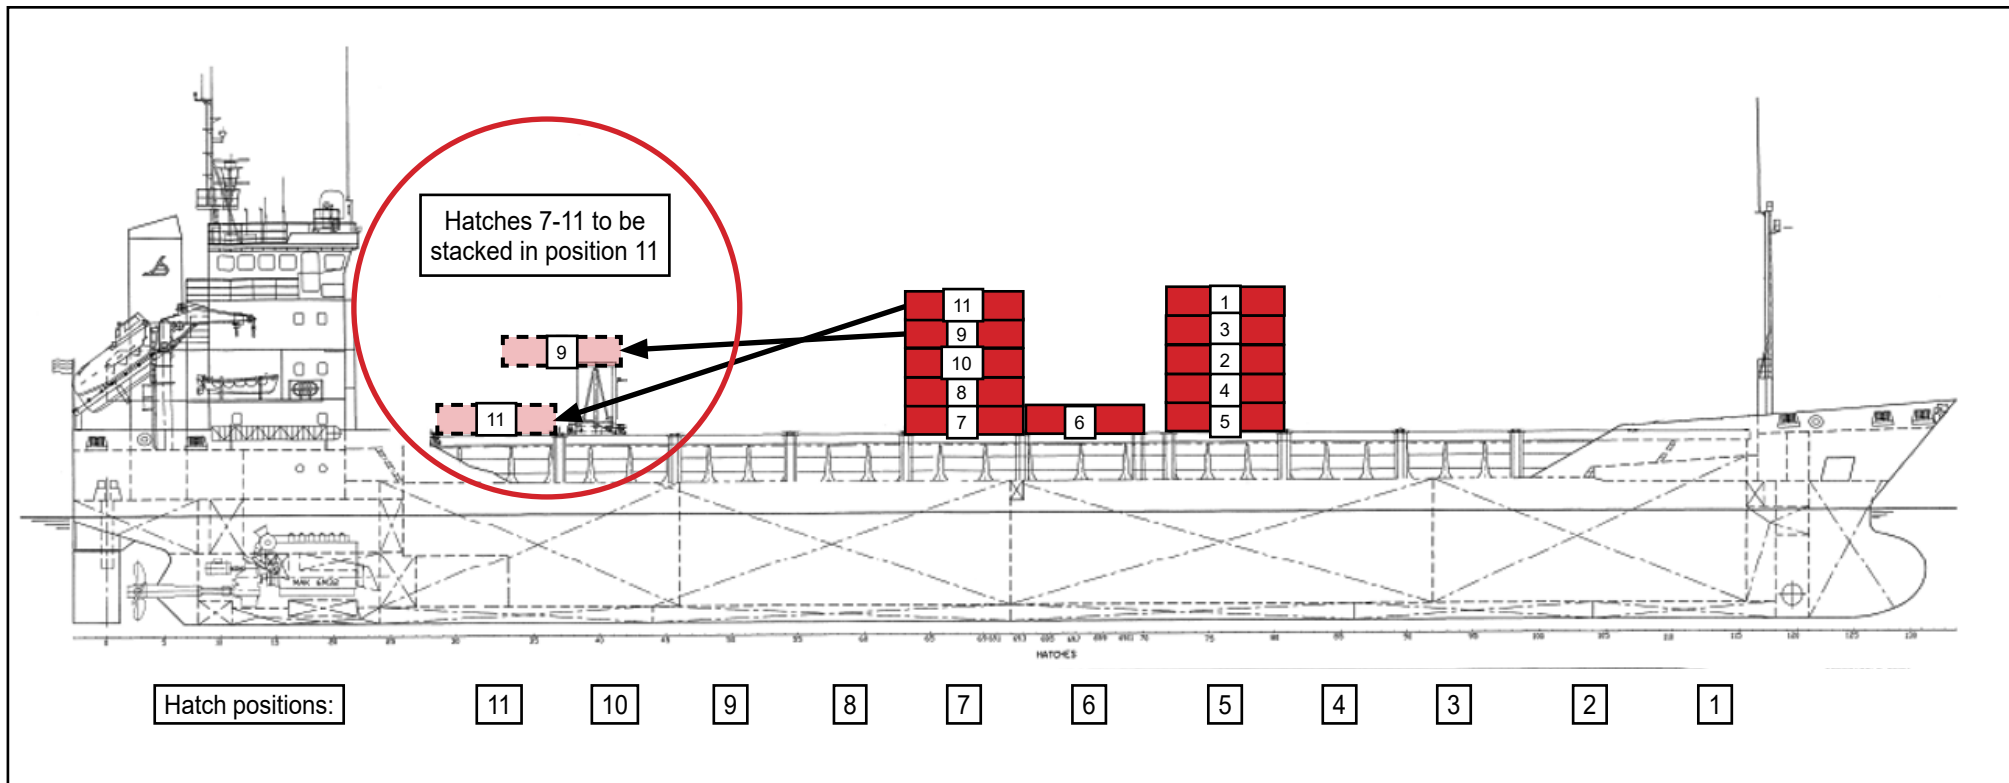
**Figure 2:** Hatch configuration before and at the time of the accident

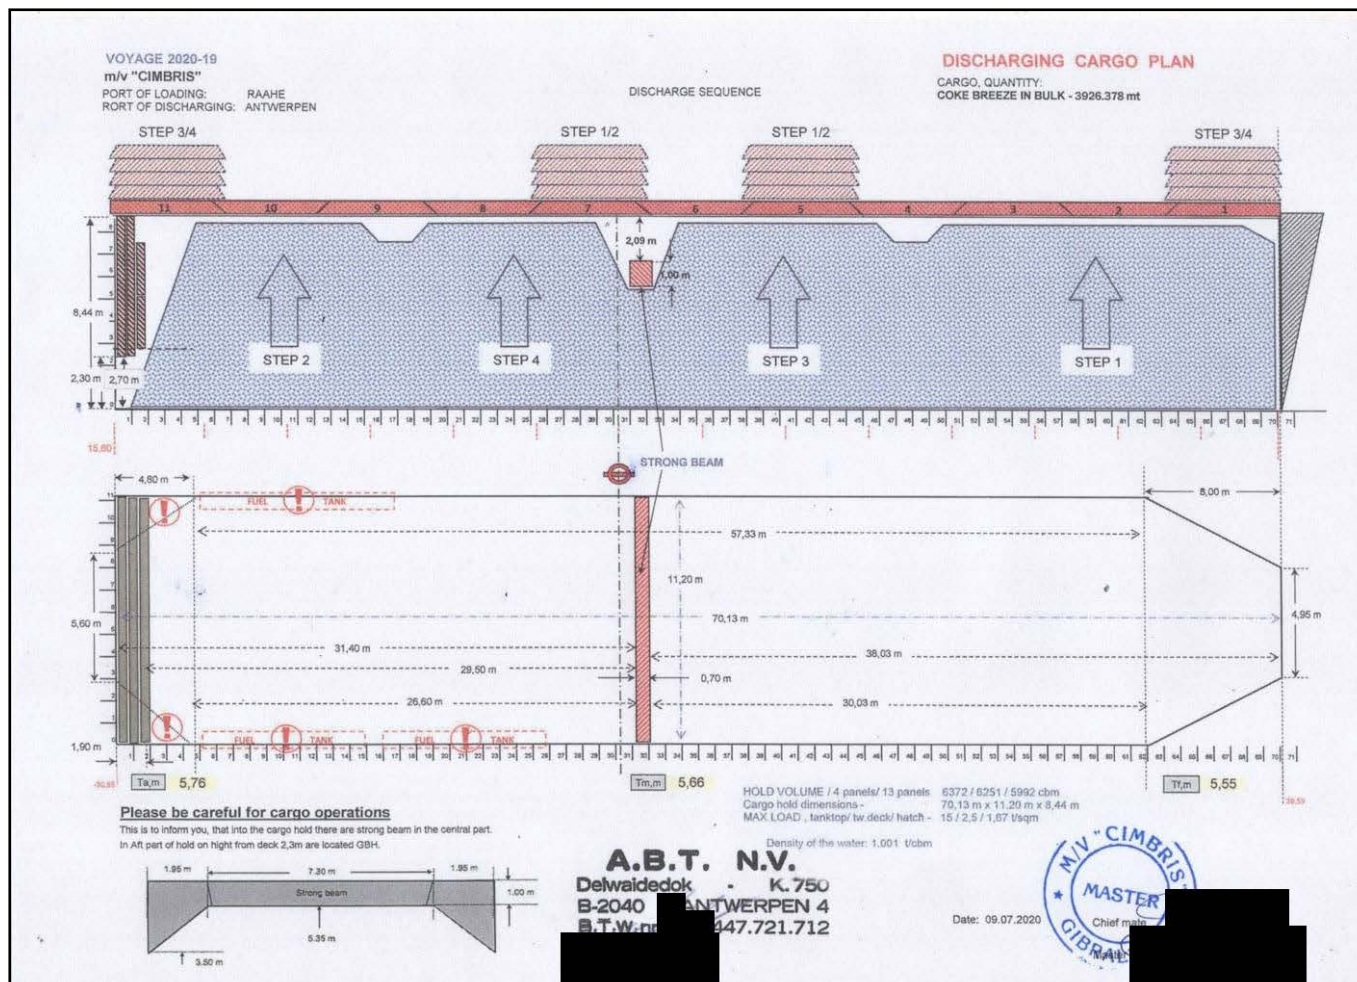
Figure 3: Cimbris' cargo discharge plan

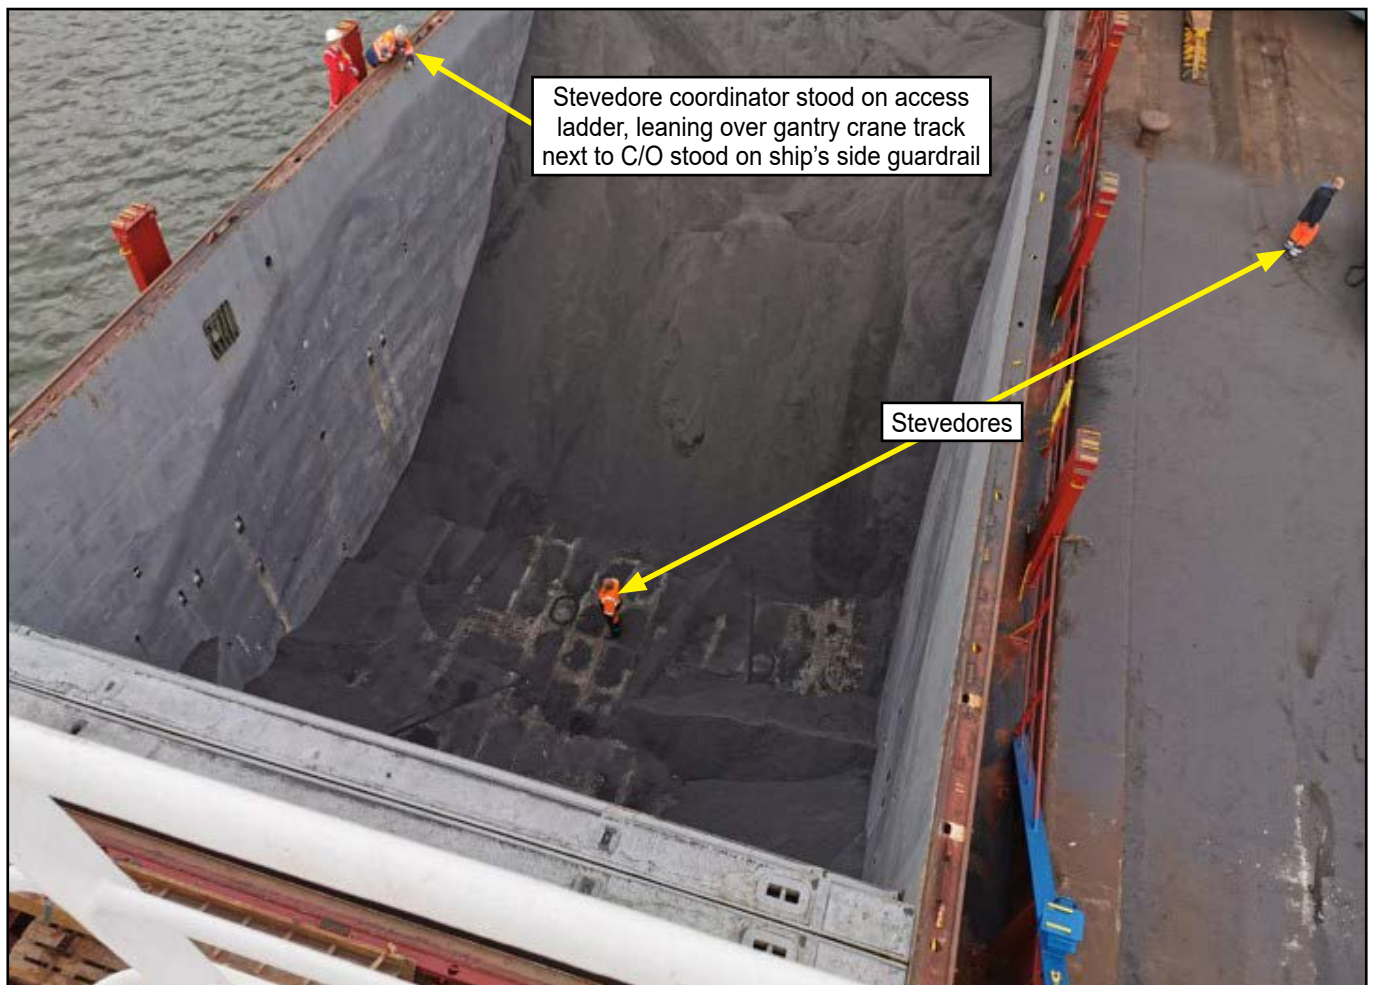
**Figure 4:** Photograph taken by ship's crew prior to front-end loader being lowered into aft end of cargo hold

Exactly when and why the stevedore coordinator placed himself in the path of the moving crane is unclear. However, it is most likely that his intention was to lean over the hatch coaming and communicate with, or assess the progress made by, the stevedores working in the hold. The port workers could communicate with each other using their handheld radios; however, it was standard practice for the stevedore coordinators to climb onto the hatch coaming to observe and shout down to the team working in the holds below (**Figures 4 and 8**).

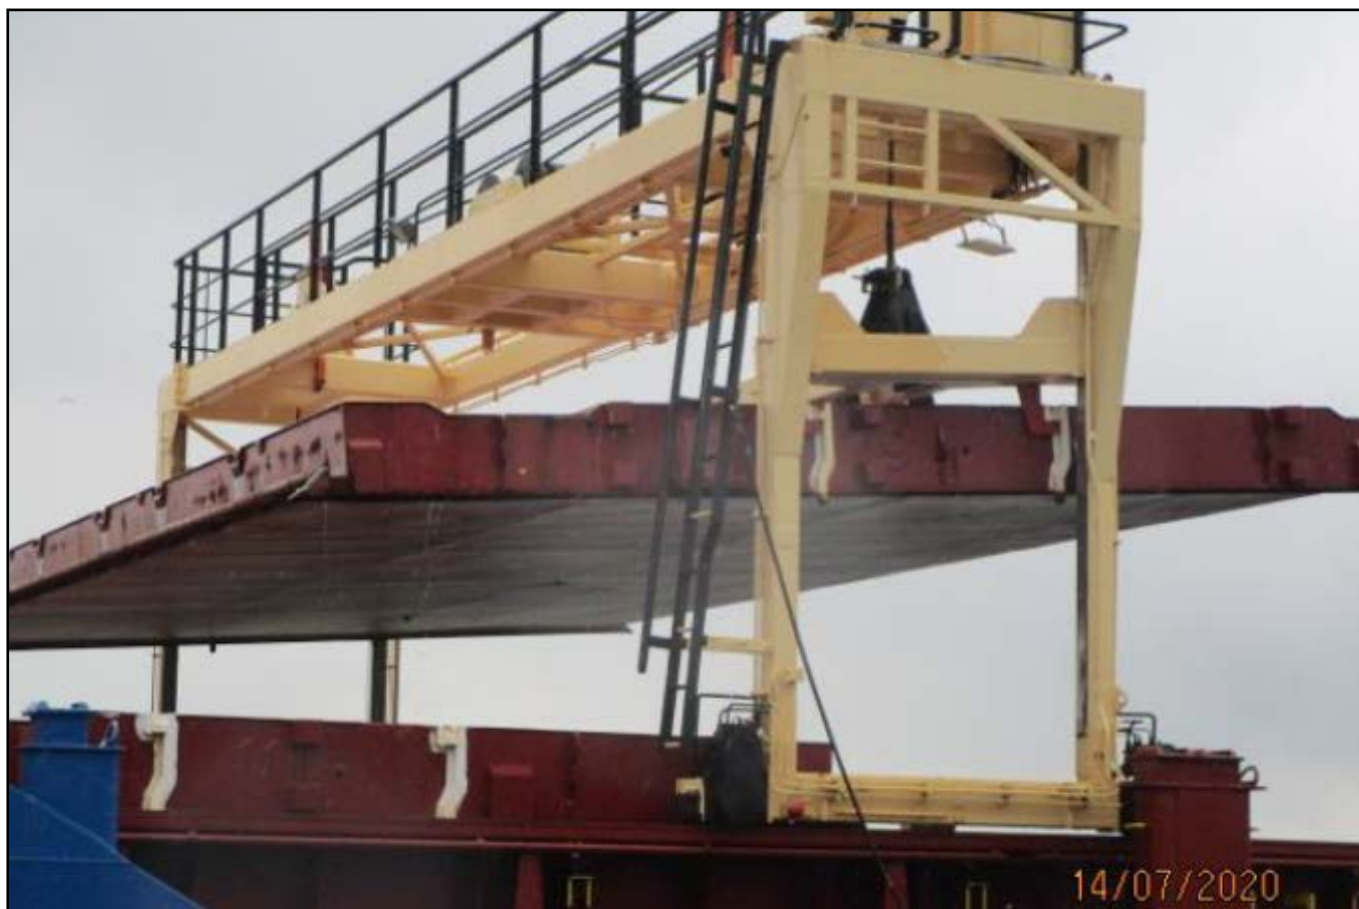
At about 0900, as the C/O drove the gantry crane over hatch cover position 10, the crane suddenly stopped (**Figure 5**). The C/O did not know why the crane had stopped, but the stevedore foreman, who saw the stevedore coordinator's head appear above hatch cover 11 on the port side, immediately realised that there had been an accident and shouted up to the C/O. The C/O climbed down from the crane and ran with the foreman to the port aft walkway, where they found the stevedore coordinator wedged between the aft leg of the gantry crane and hatch cover 11, a gap of approximately 130mm (**Figure 6**).

**Figure 5:** Gantry crane (in accident position) with hatch cover 9 suspended

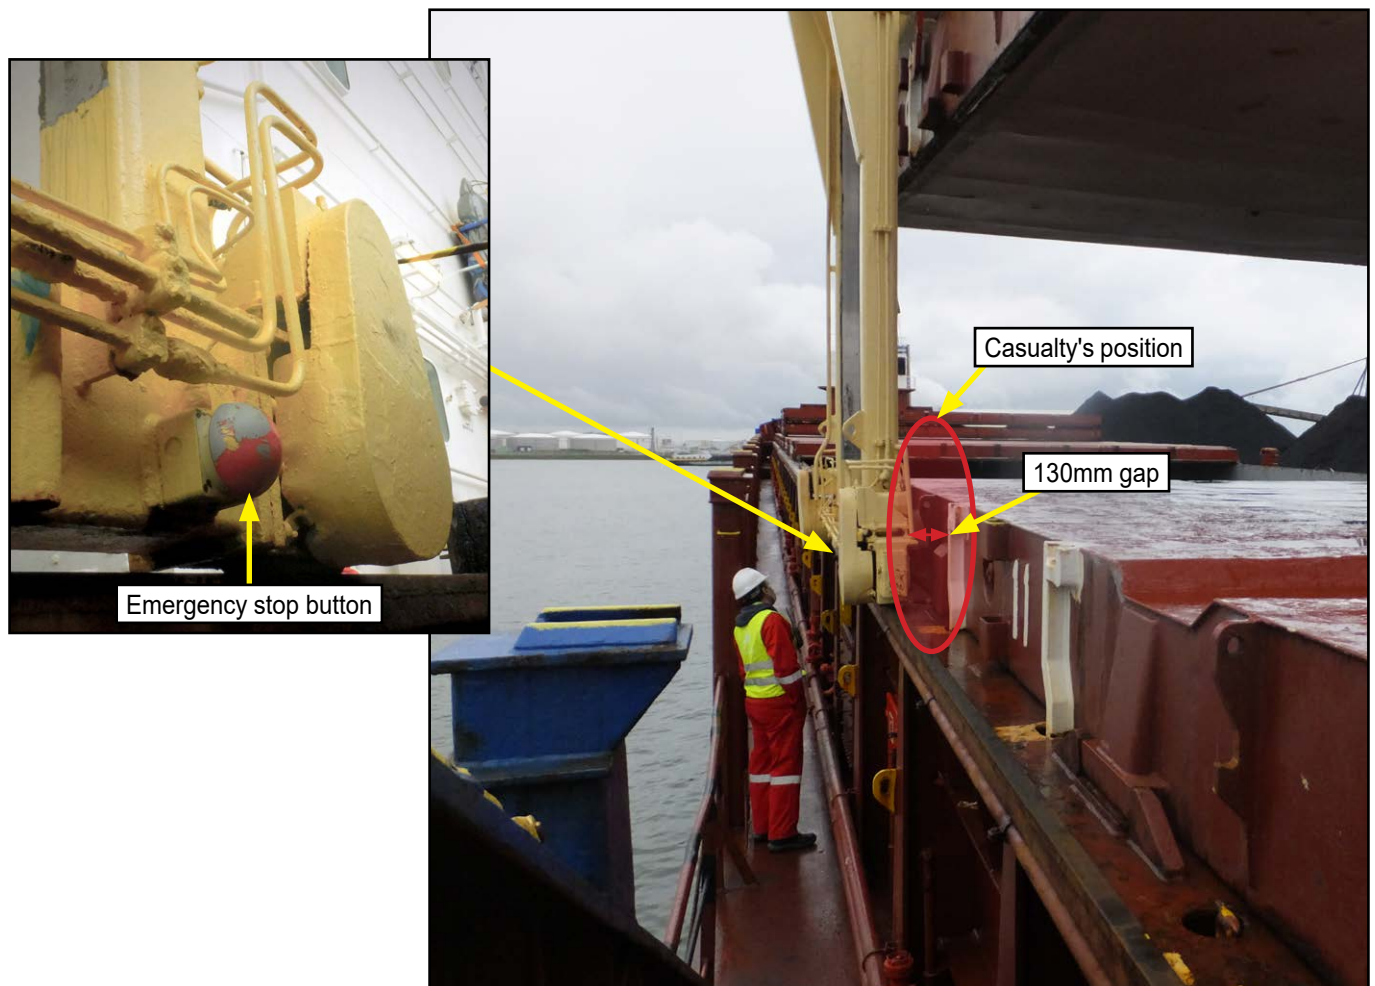
The gantry crane was inspected and its emergency stops, movement warning bell and flashing light were tested and found to be operating correctly. The warning bell was loud and, although it was not possible to replicate the sound of the front-end loader engine in the hold, it was considered unlikely that the bell would have been drowned out by the ambient noise at the time of the accident. The gantry crane flashing light was clearly visible, even in daylight, but the suspended hatch cover obscured it from the position the stevedore coordinator was found as the crane and suspended hatch cover approached. When in motion, the crane caused significant vibration, which could be felt when leaning over the hatch coaming.

**Figure 6:** View of location where stevedore coordinator was discovered with inset showing position of emergency stop button

When the C/O moved the first hatch cover aft (hatch cover 11), the stevedore coordinator was working at the forward end of the cargo hold. At about the time the C/O was preparing to move the second hatch cover, the stevedore coordinator walked aft to check on the team working in the aft part of the hold. At some point before the accident, the stevedore coordinator must have climbed up the side of the hatch coaming and positioned himself between the moving gantry crane and hatch cover 11. Once trapped, he was unable to alert the C/O or stop the crane. This was probably because he had little time to react and was unable to reach the emergency stop positioned on the outer side of the crane structure (**Figure 6**).

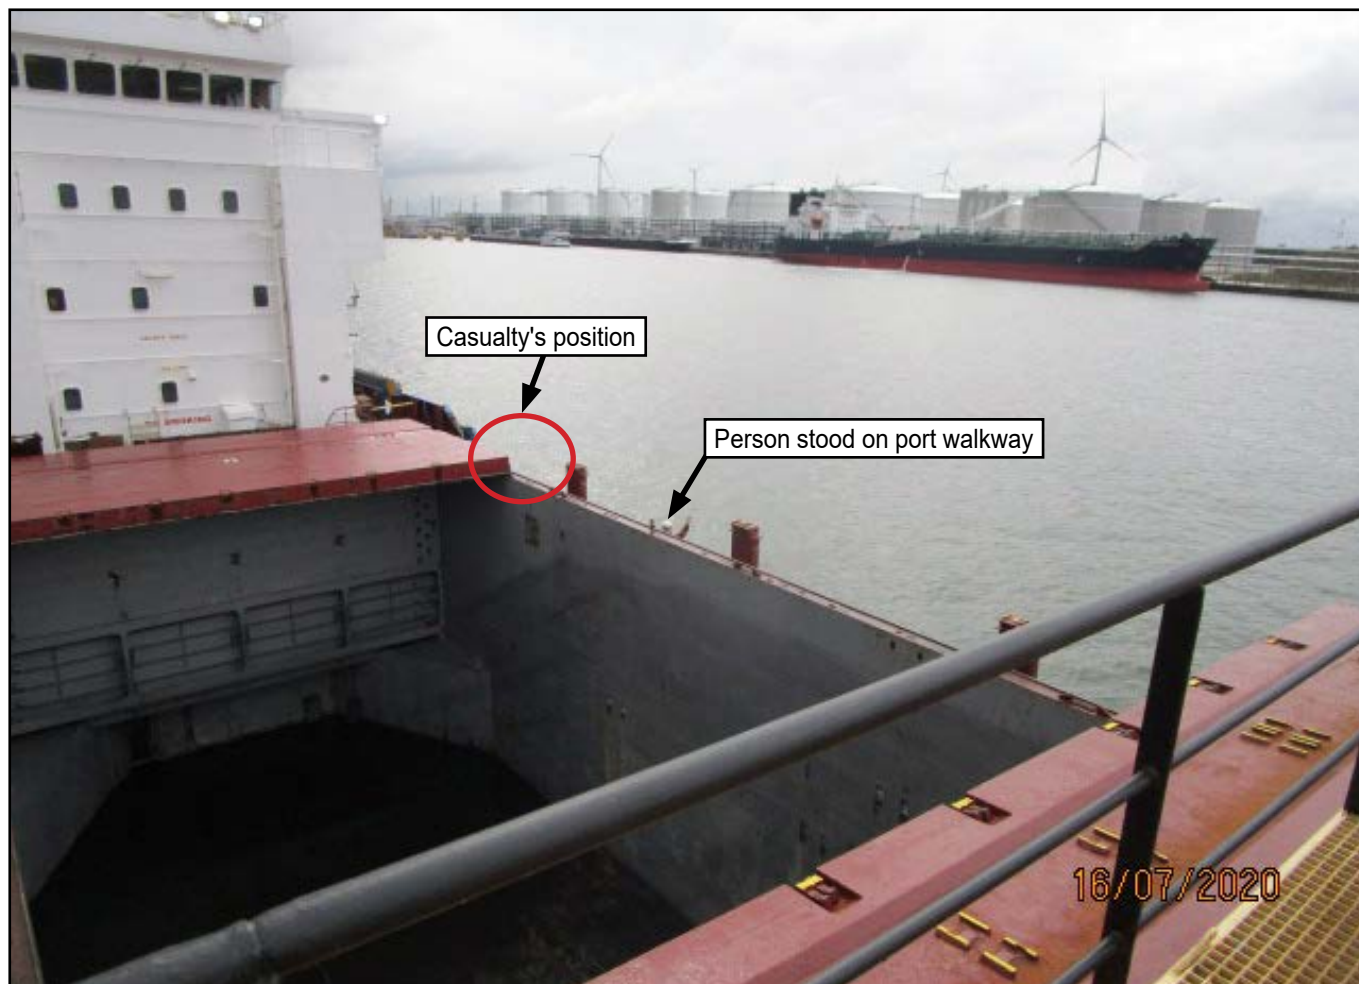
**Figure 7:** View from gantry crane control position toward location where stevedore coordinator was discovered

While it might have been difficult to spot a person standing on or walking along the port walkway (**Figure 7**) from the gantry crane control position, the stevedore coordinator would have been clearly visible had he climbed on to or leant over the top of the hatch coaming. This was particularly so given that the stevedore was wearing high-visibility clothing. It is therefore unlikely that the stevedore coordinator was on the hatch coaming before the C/O started repositioning the second hatch cover.

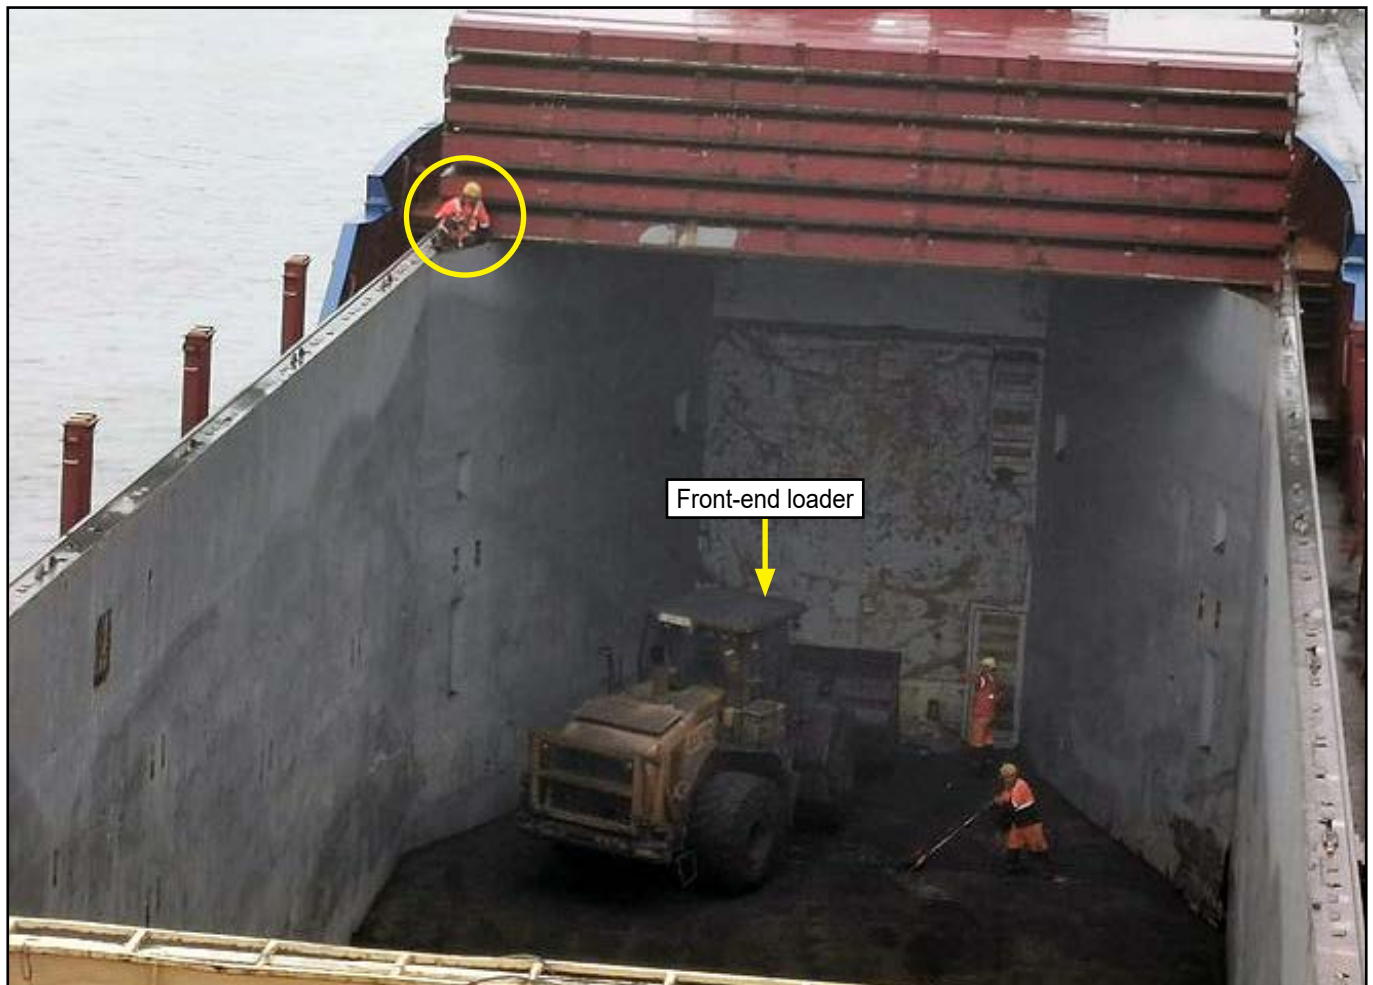
During *Cimbris'* visit to Antwerp, the vessel's crew witnessed the port stevedores carrying out several unsafe acts. On the day of the accident, these included the failure to wear hard hats (**Figure 4**) and climbing over the coaming and sliding down the cargo to access the holds. The day after the accident, the replacement stevedore coordinator was observed sitting on the hatch coaming with no form of fall restraint (**Figure 8**).

**Figure 8:** Photograph taken by ship's crew after the cargo operations resumed, showing stevedores working in the forward end of the cargo hold with a stevedore coordinator sat on top of the cargo hatch coaming
