Report on the Investigation of the
Failure of the hatch cover gantry crane on board

CIMBRIS

alongside in the port of Tekirdag, Turkey

4th April 2008

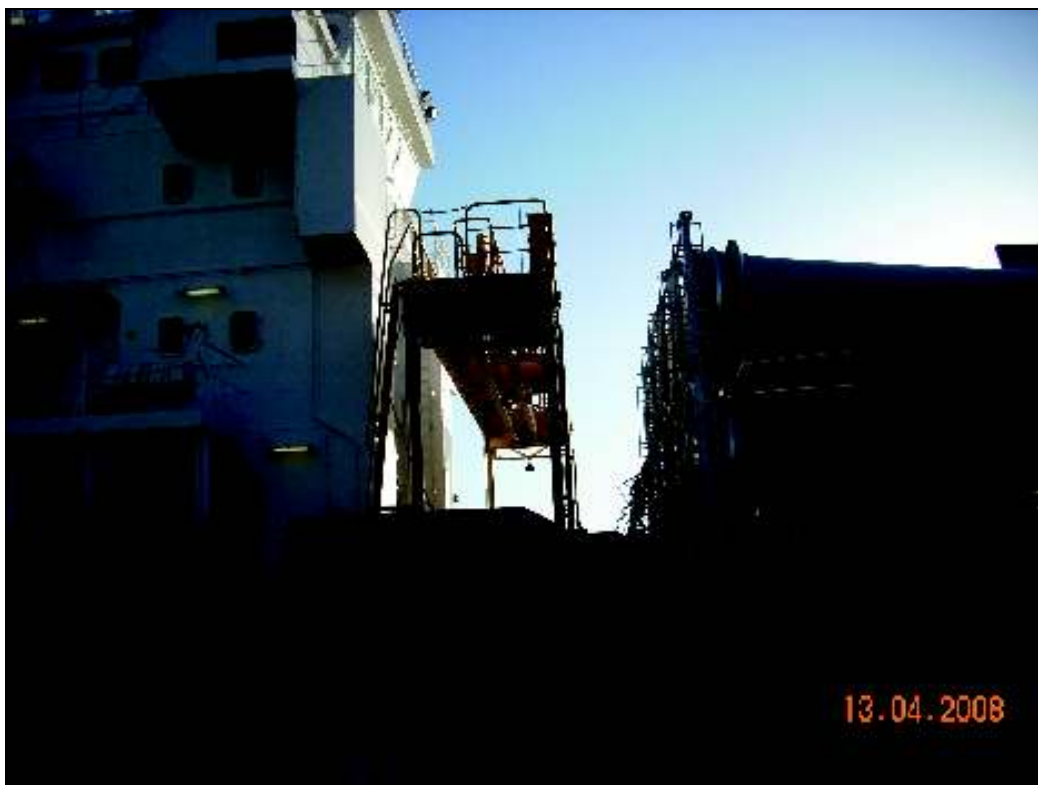
Figure 2. Side view of hatch cover gantry crane with the lifting frame in the stored position

The hoist wires failed at a distance of 4320 mm and 4440 mm from the end termination that connects the hoist wire to the main deck lifting frame or tween deck lifting beam. When the crane was not in use and in its stored position as per **(Figure 2)** the point of break would be approximately mid way between the hoist drum and the outboard sheave. The wire in the region of the break would therefore be subject to the weather when the vessel was at sea to a greater extent than the wire that was on the hoist drum.
